CSC Charlotte South

EPA R4 NPDES Inspection

Inspected on 5/29/19

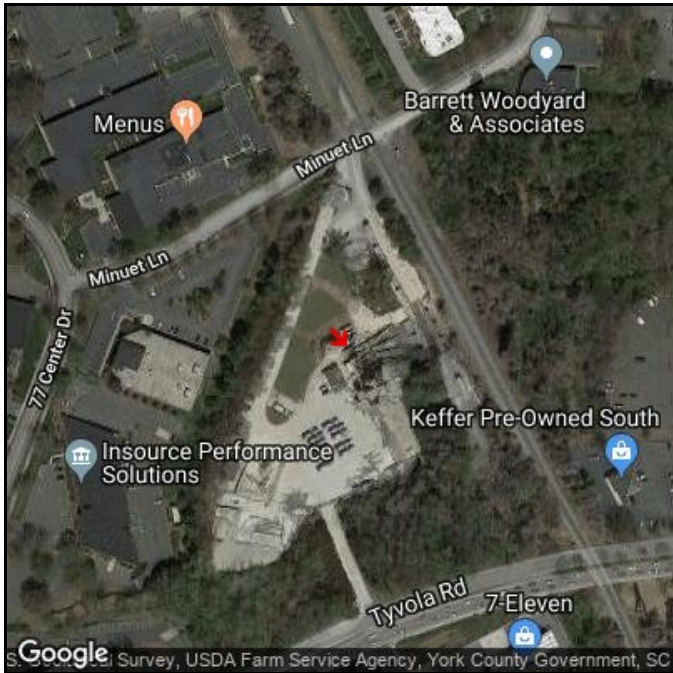
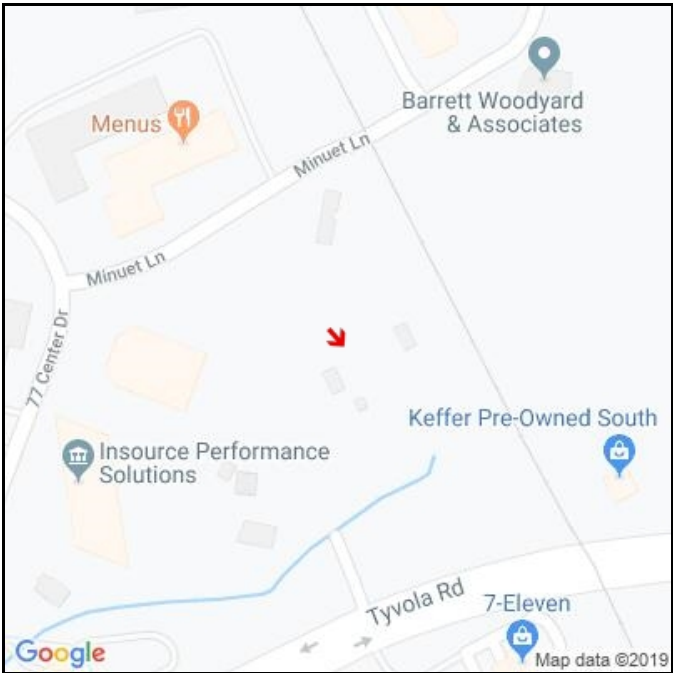
Attributes	
Description	Secondary containment for admixture tanks is broken in this location and two other locations, not shown. Rainwater and spilled liquid from this area would flow into overall site capture tanks shown in later photos.

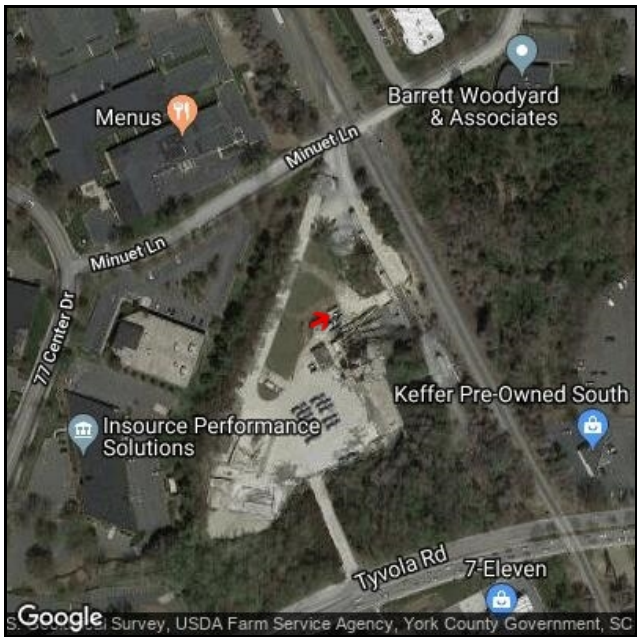
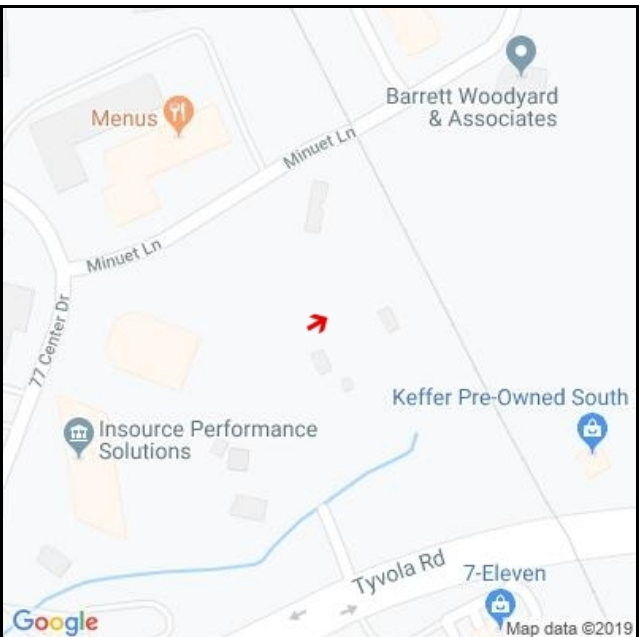
Attributes	
Description	First of two shots of the area below the aggregate storage bins, and the aggregate and sand conveyor belts. Aggregate and sand materials typically have some moisture content. This area also experiences rainfall on these piles and from the northerly portion of the work area, which is captured nearby. Trucks are emptied into the bins from the bridge above.

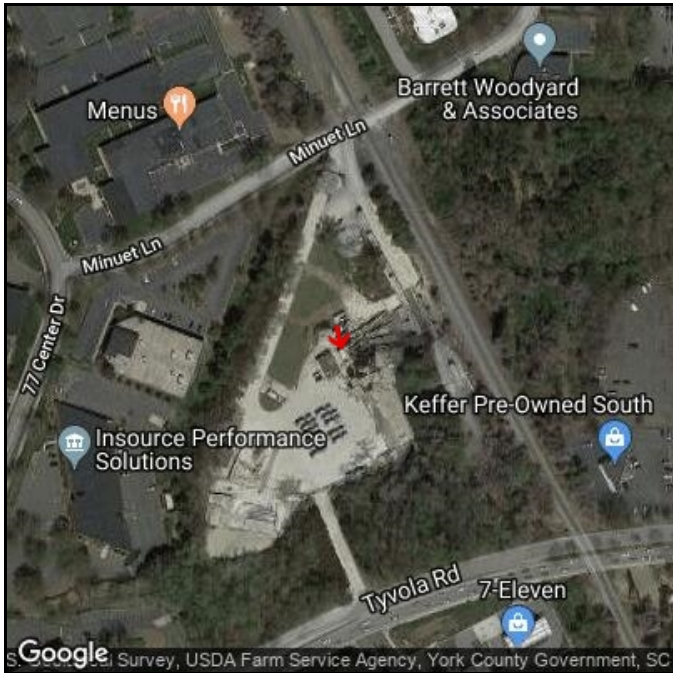
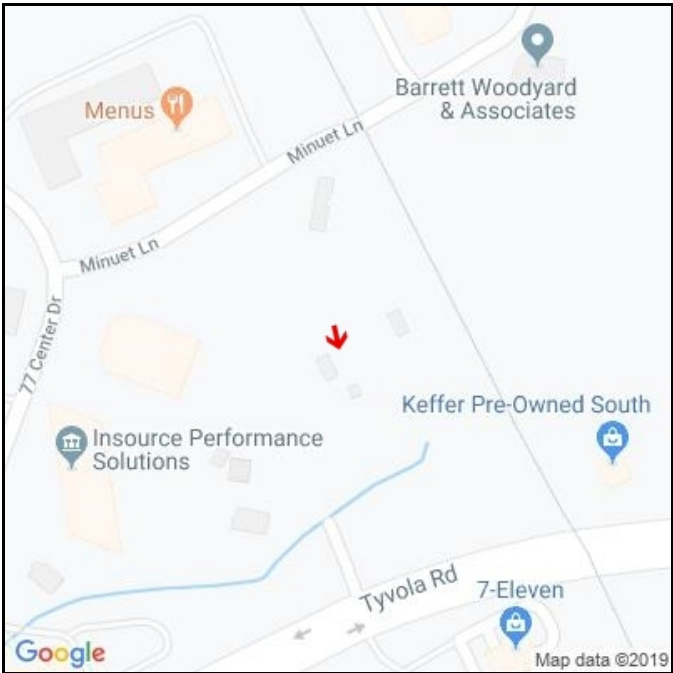
Attributes	
Description	Second view of area below aggregate/sand belts. In background but not shown (between piers and trees, right-middle of photo) is the area that captures the stormwater hitting this area. Water flow and camera angle are southerly.

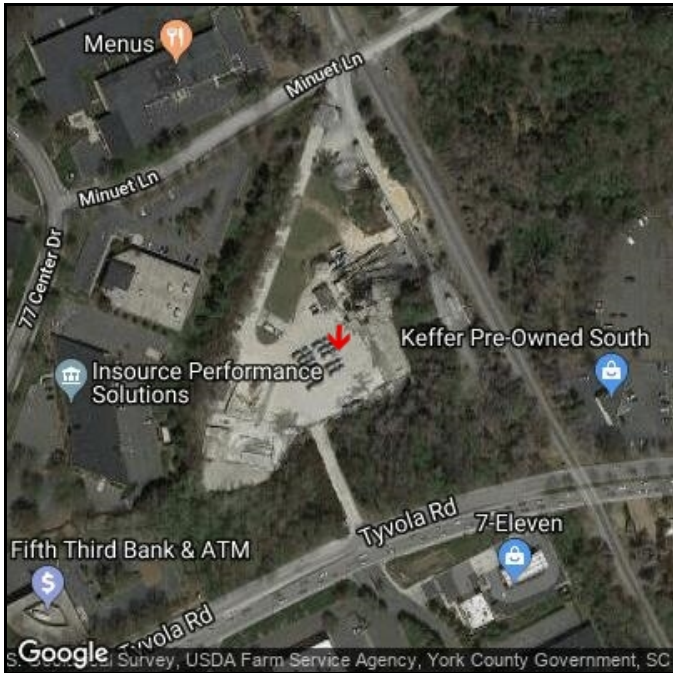
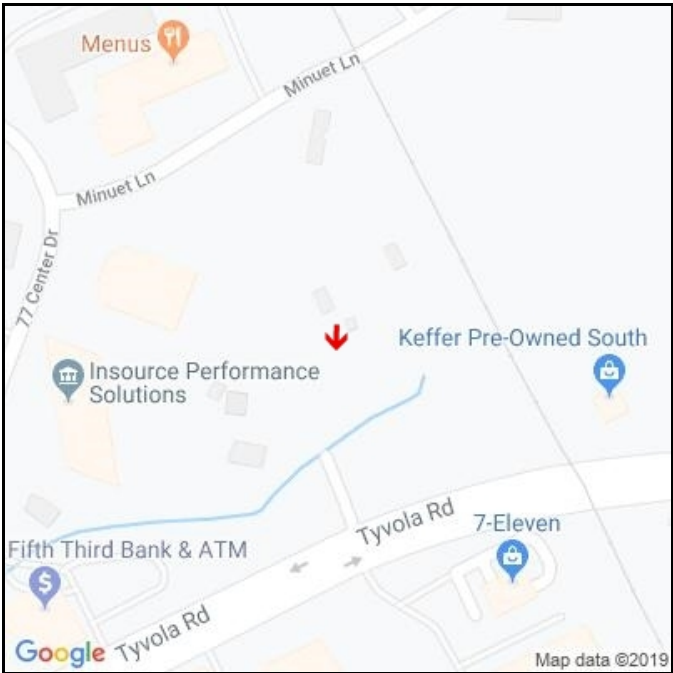
Attributes	
Description	Truck being washed out using self-supplied water in middle of work area. This rinse-water was flowing towards the basin in photo DSCN1803.

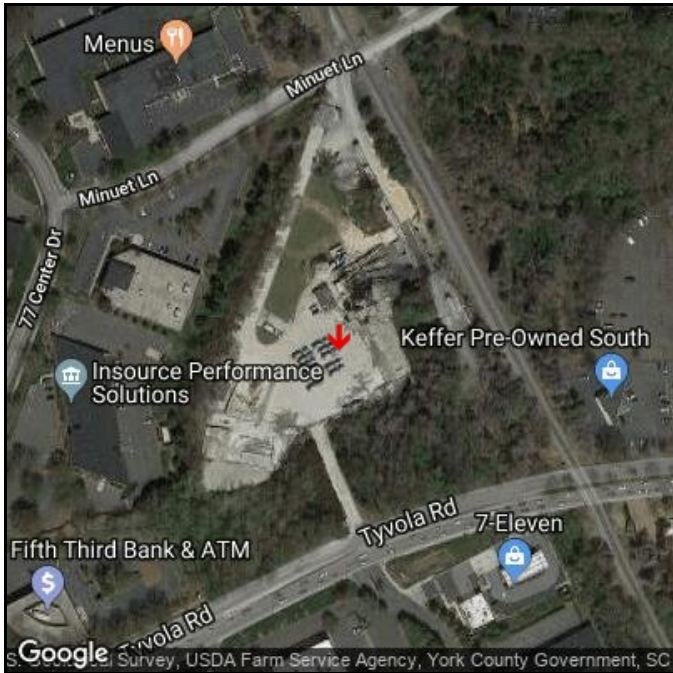
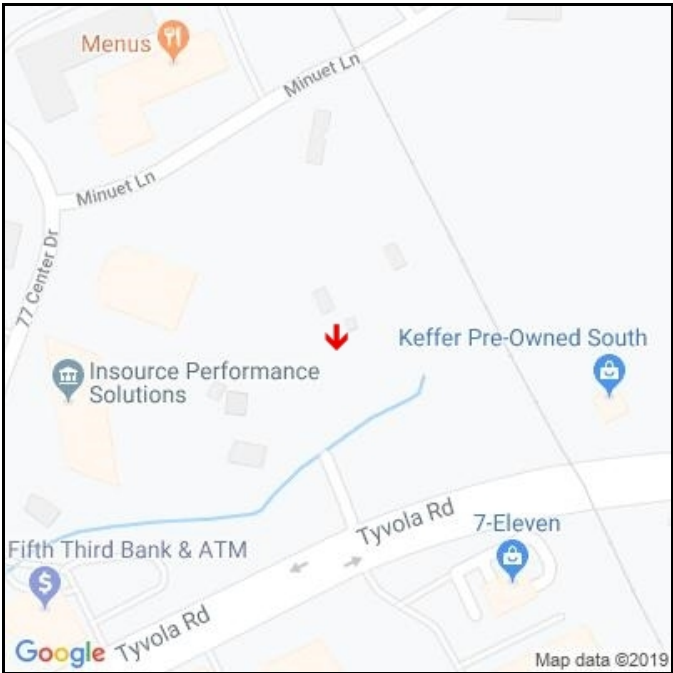
Attributes	
Description	Truck being washed out using self-supplied water in middle of work area. This rinse-water was flowing towards the basin in photo DSCN1803.

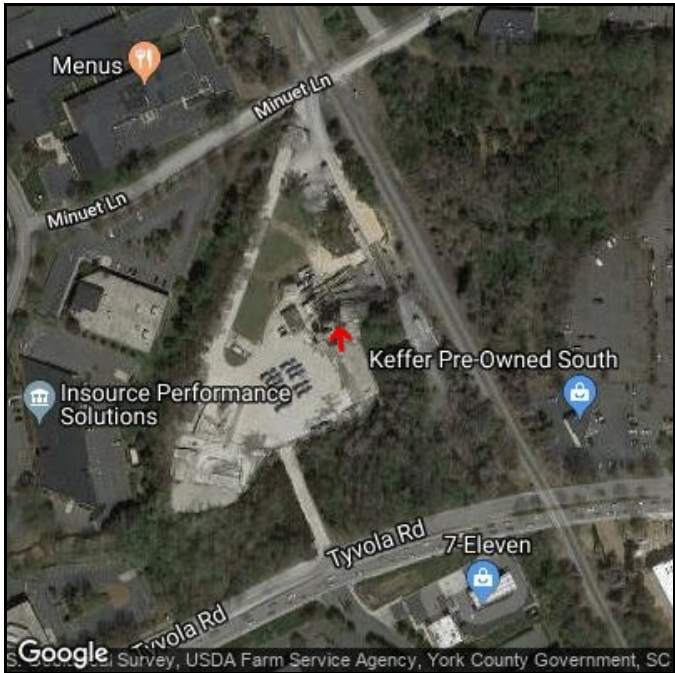
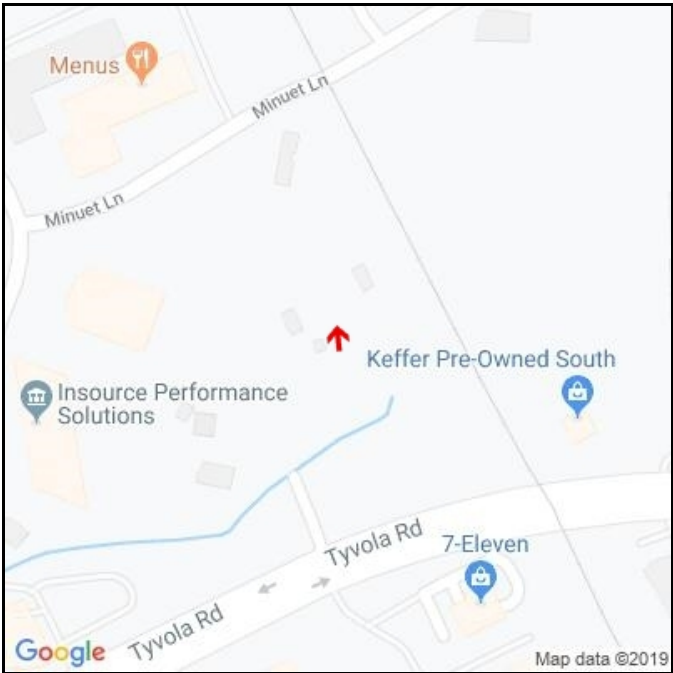
Attributes	
Description	Another view of drainage from belt/storage area. Looking northerly.

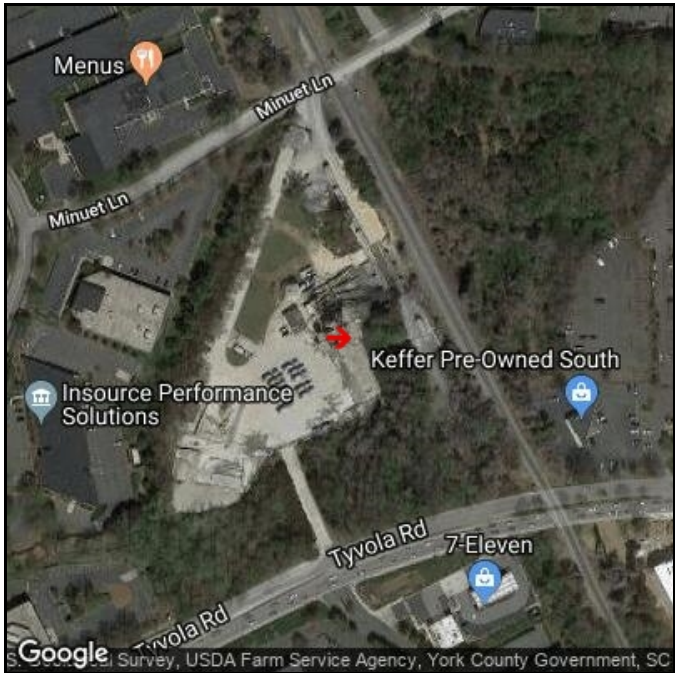
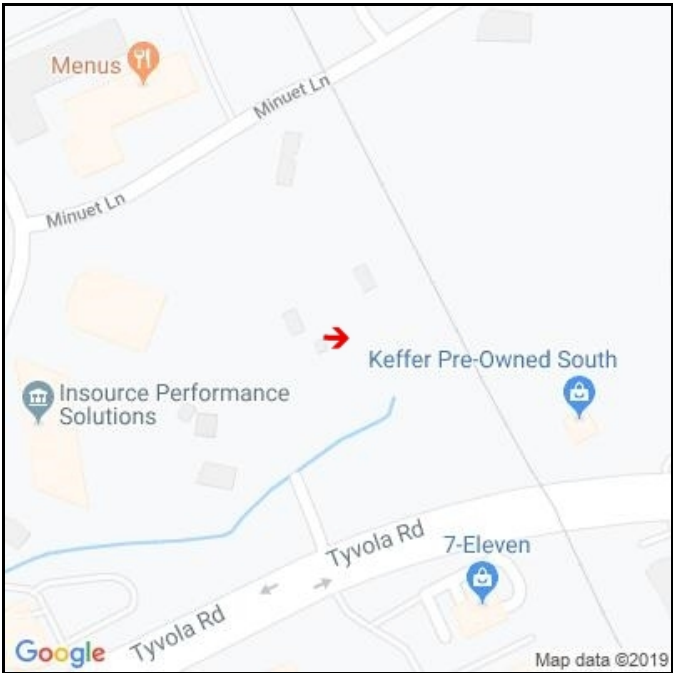
Attributes	
Description	Northerly end of basin capturing stormwater runoff from most of yard area.

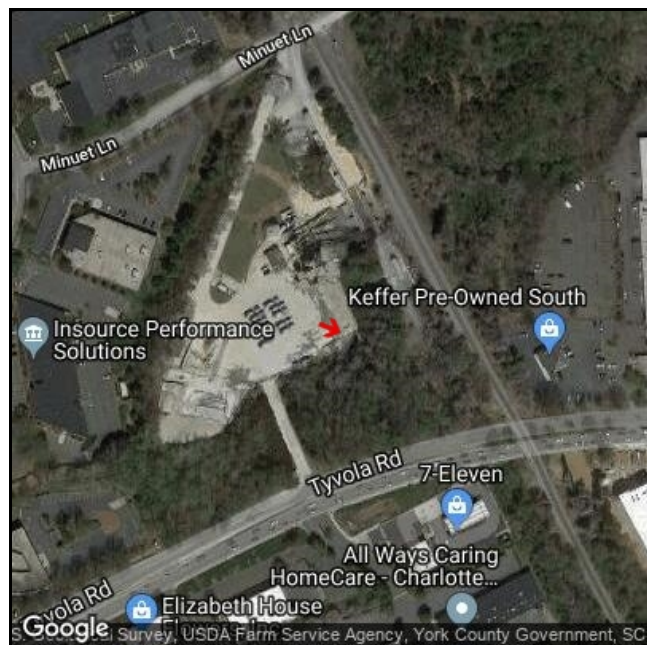
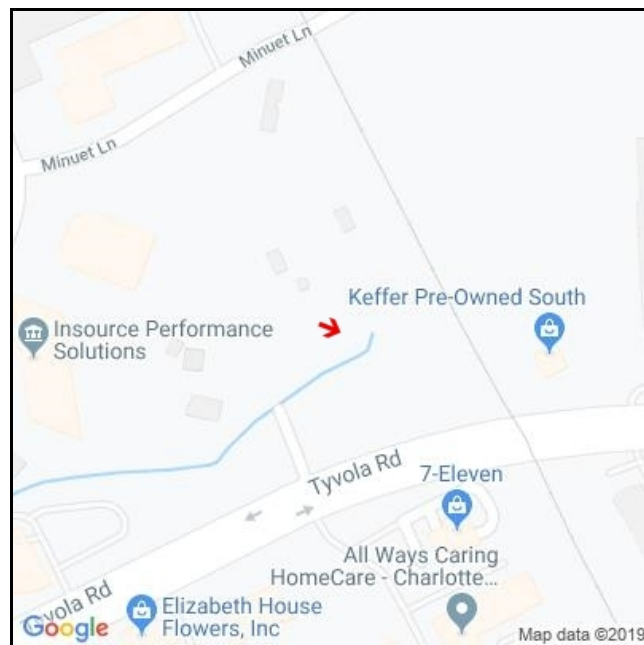
Description	View of CO ₂ tanks, and portion of control shed for CO ₂ application to wastewater and stormwater for pH adjustment in the final holding basin prior to discharge. System was installed in March 2019. Water is only discharged when necessary; most water is recycled into products. Treatment basin is behind wall in middle of photo. PVC pipe control lines and feed lines are visible.
-------------	---

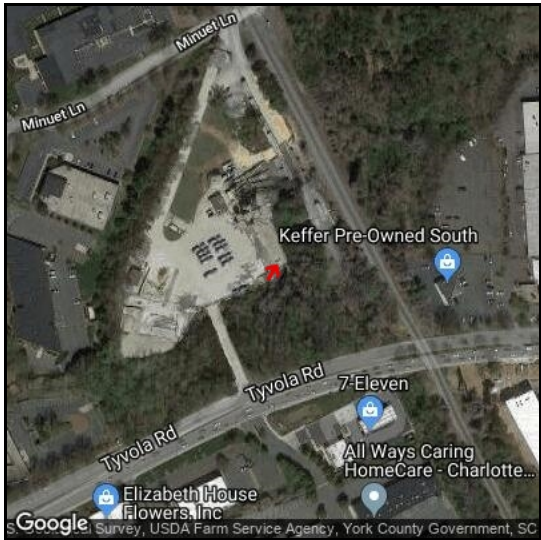
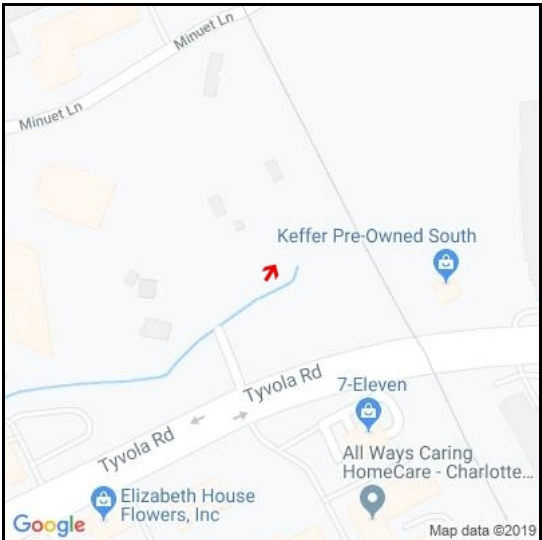
Attributes	
Description	First of four panning shots of the outlet structure area. Staff stated that the water in the ditch was from the adjacent roadway, backing up towards their outlet structure. Outlet structure observed as not discharging at time of inspection. CO ₂ pH adjustment feed lines and return lines are visible on the wall. Outlet opening itself is not visible in this picture. Poured concrete wall upper left separates two capture basins from treatment basin. Stacked block with liner – left of photo, background, is basin where water set for discharge is accumulated for treatment. Discharged water would mingle with muddy water in right foreground.

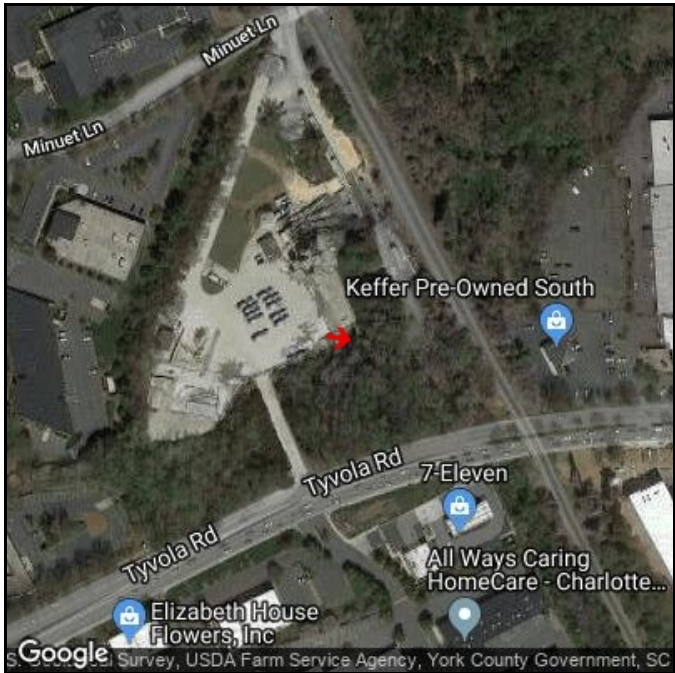
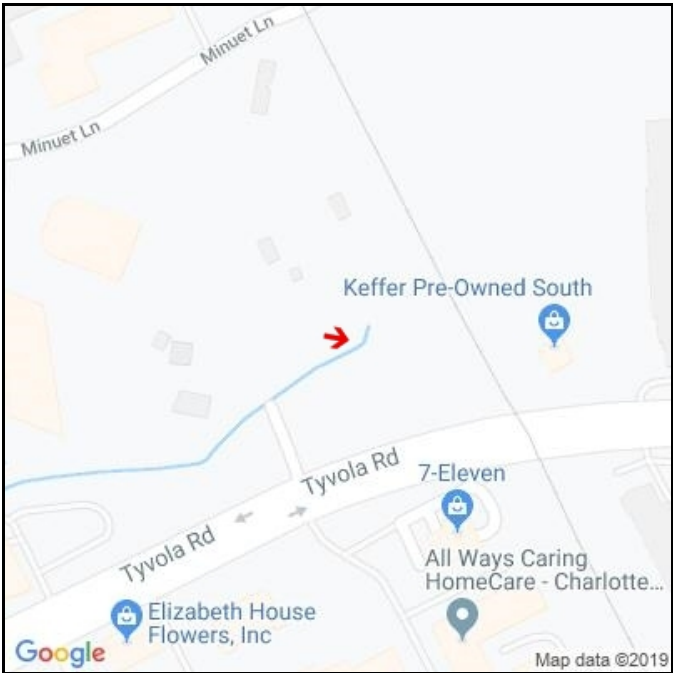
Attributes	
Description	Second of four panning shots showing receiving ditch with muddy water, stated to be from roadway runoff. Looking easterly. Flow would traverse left to right.

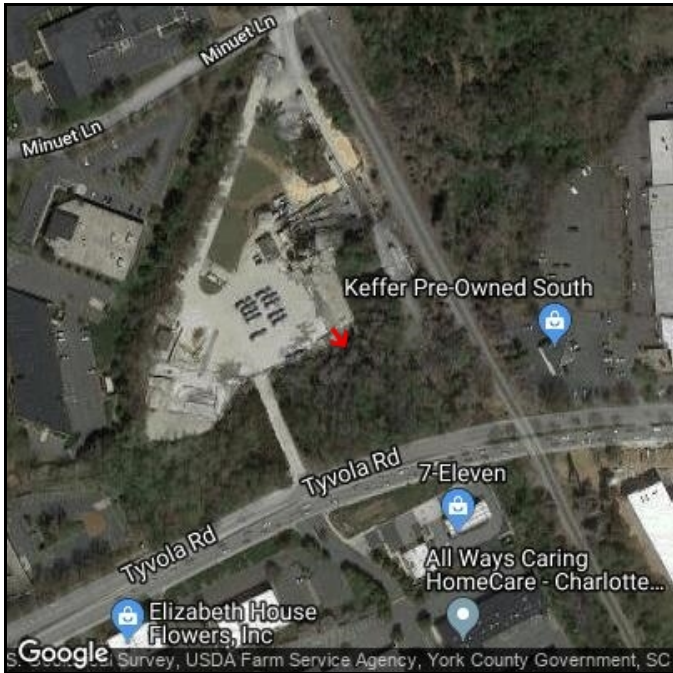
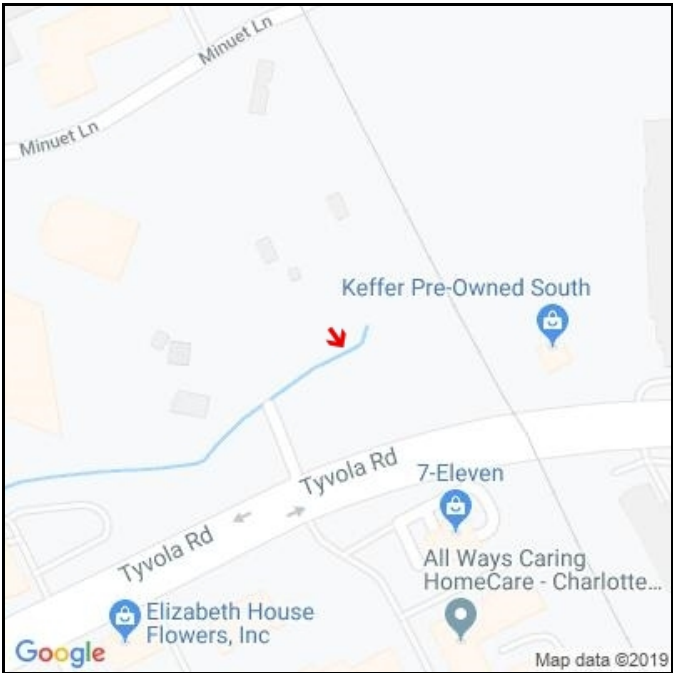
Attributes	
Description	Third of four panning shots of ditch between facility and Tyvola Road.

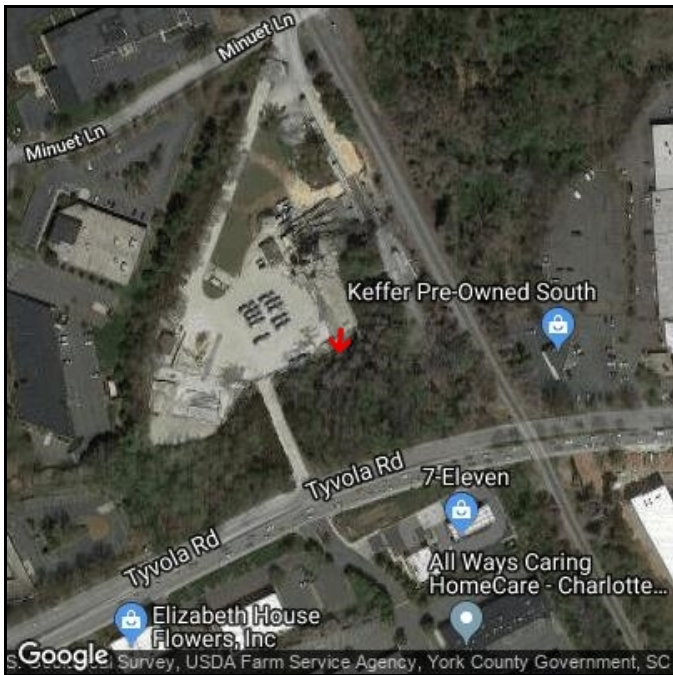
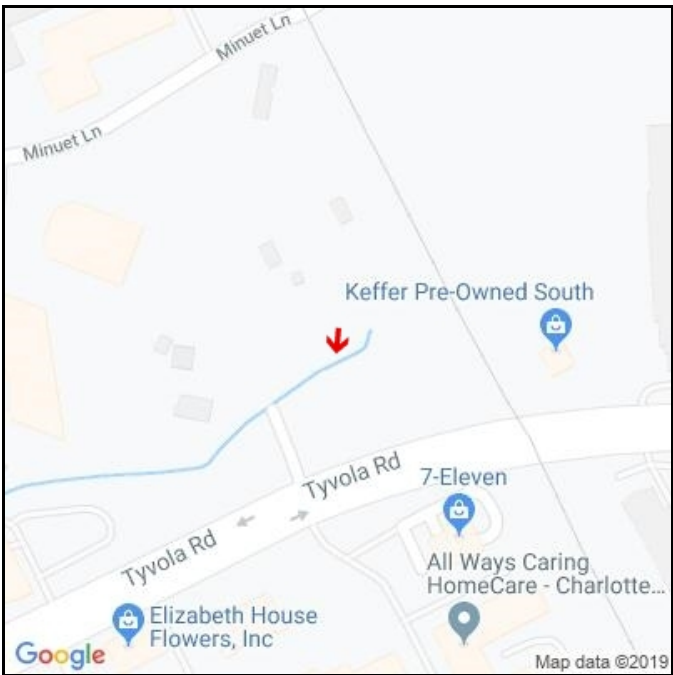
Attributes	
Description	Fourth panning shot of discharge area. Flow goes out of view into vegetated area along Tyvola Road in a westerly direction. Facing southerly.

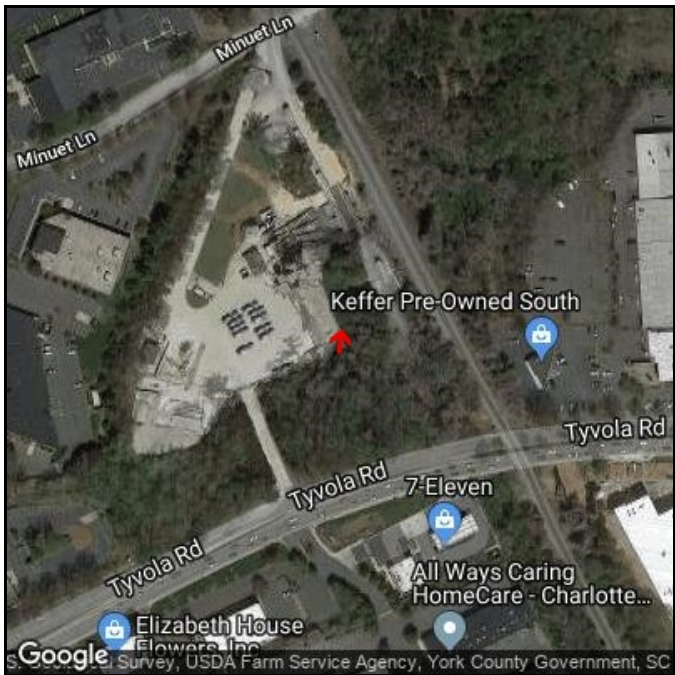
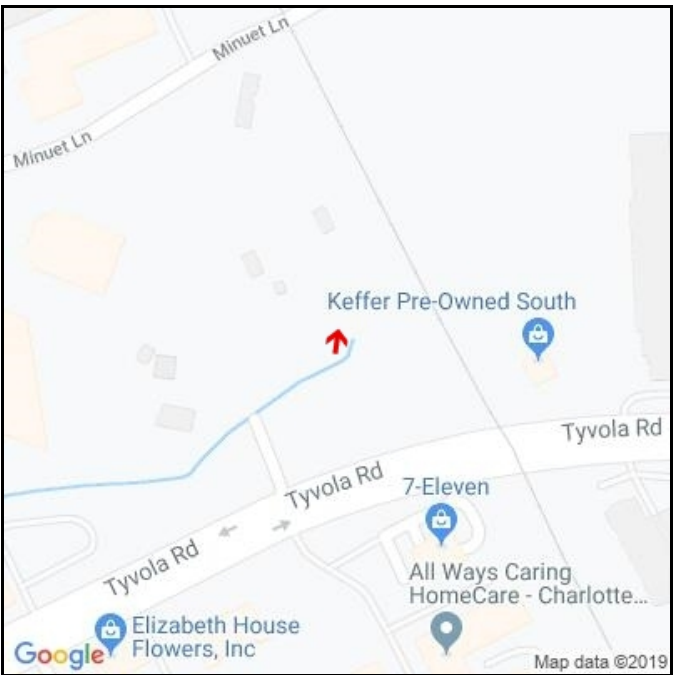
Attributes	
Description	Photo of outlet structure from outside of basin. Water was present at the bottom of the structure but was not flowing. Staff indicated that the system was not discharging. The pre-discharge basin was largely empty (upper left of photo).

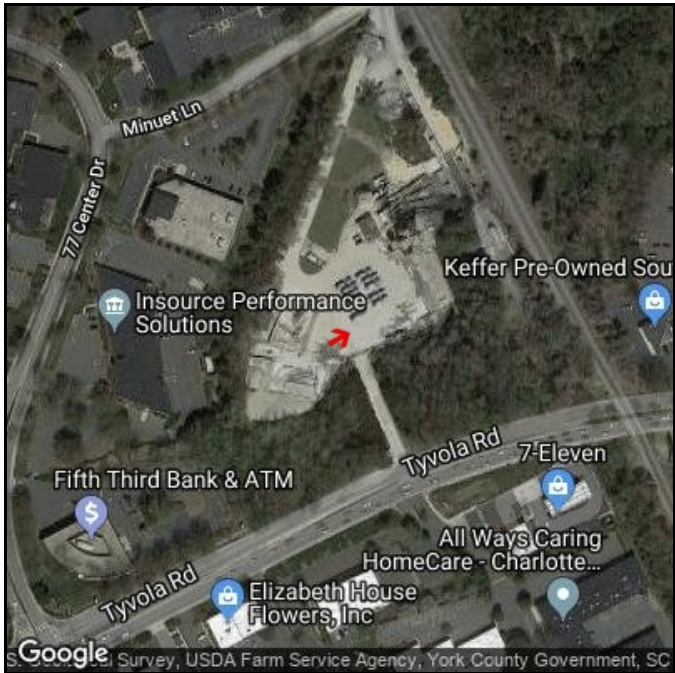
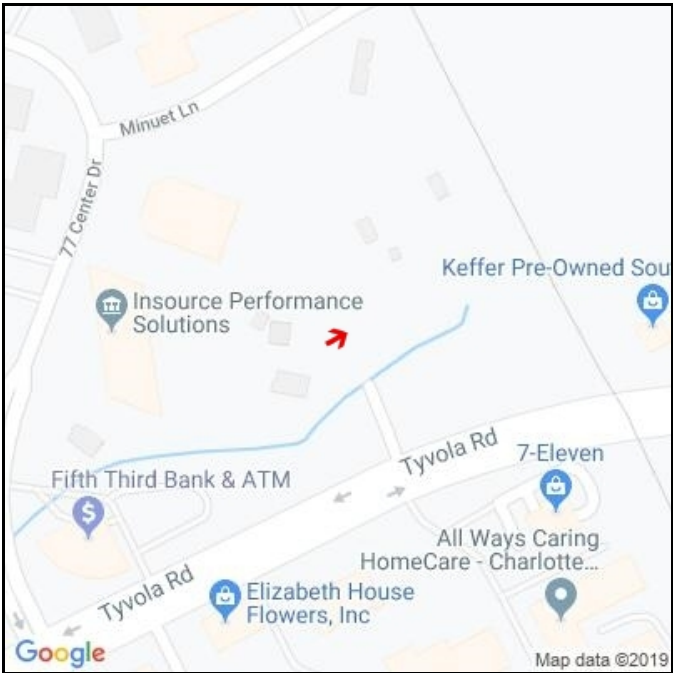
Attributes	
Description	Looking down-gradient from center-south of paved truck area, looking roughly ENE.

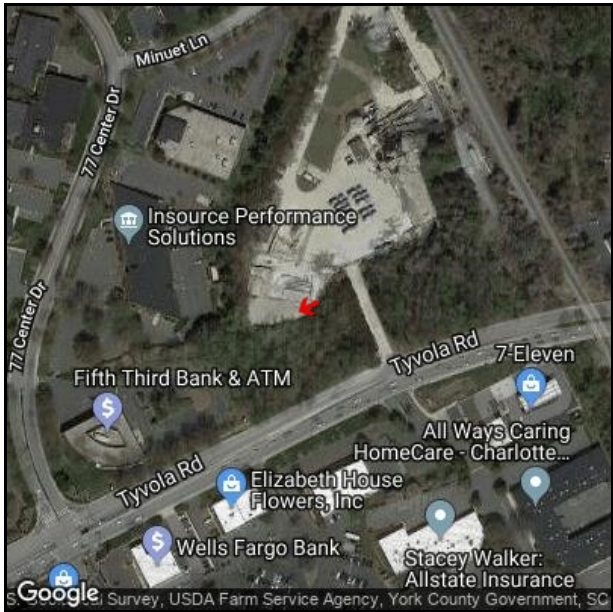
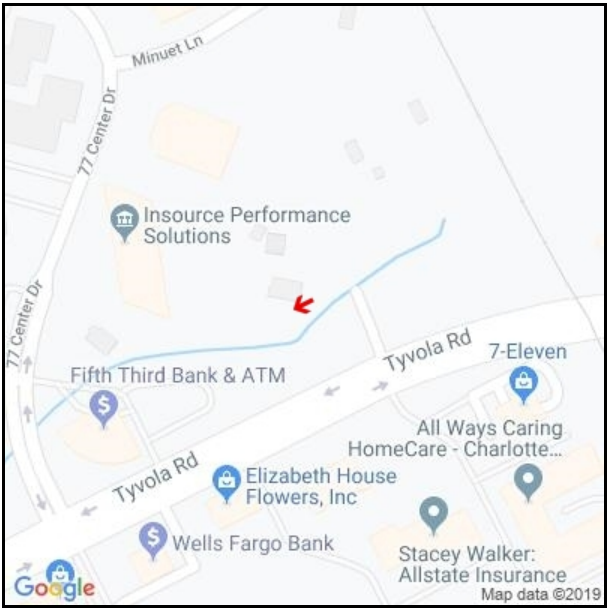
Attributes	
Description	View of former pond area that is no longer used for storage, in SW corner of work area. Limited runoff can still enter this area, but largely percolates. Berm visible in upper left of picture surrounds whole area. Formerly used for storage, the pond was taken out of service and concrete materials were removed. There is an adjacent truck wash station; the corner of poured concrete basin is just visible on right of photo. See DSCN1812.

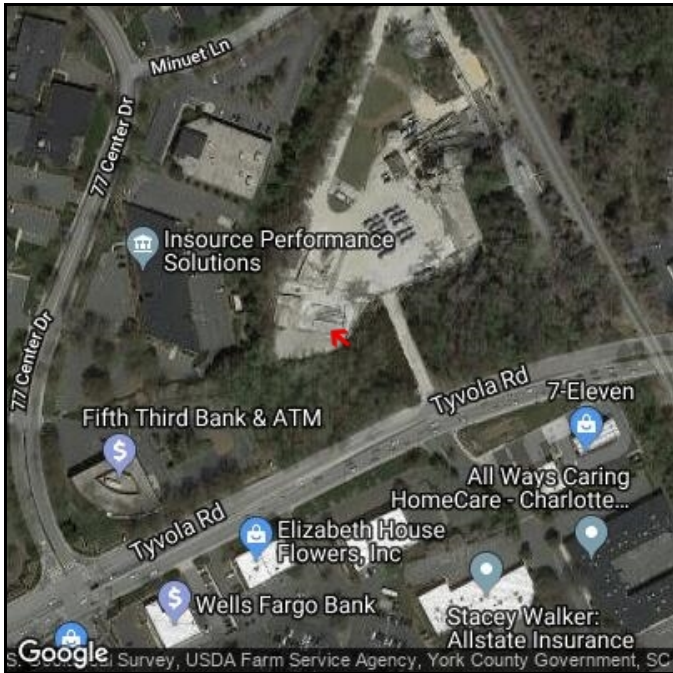
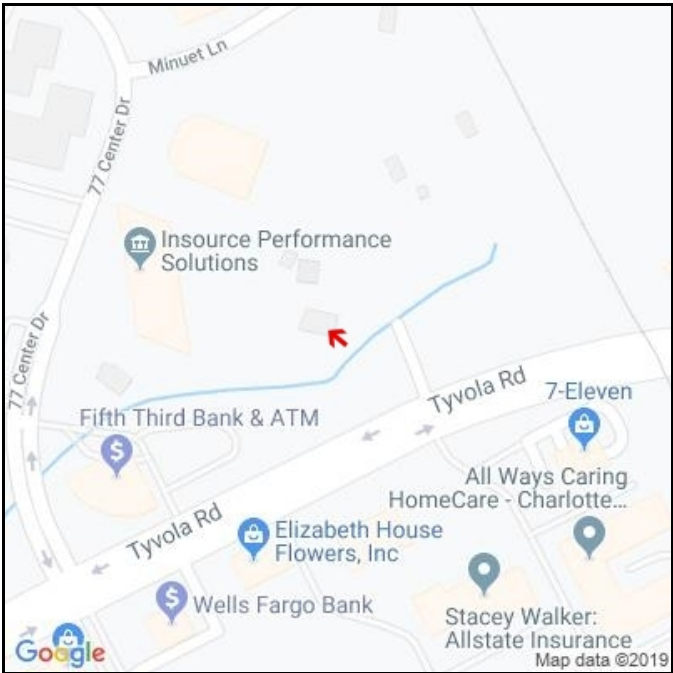
Attributes	
Description	Truck washout capture. Decanted water is reused

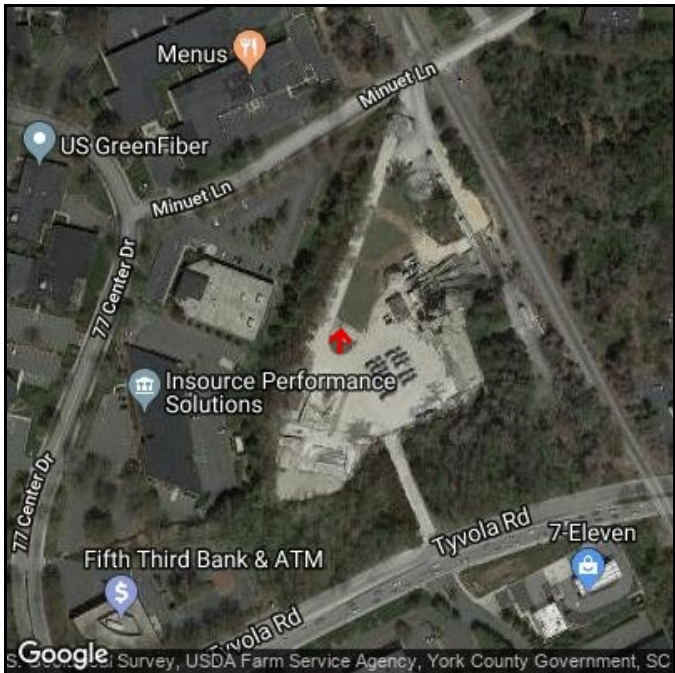
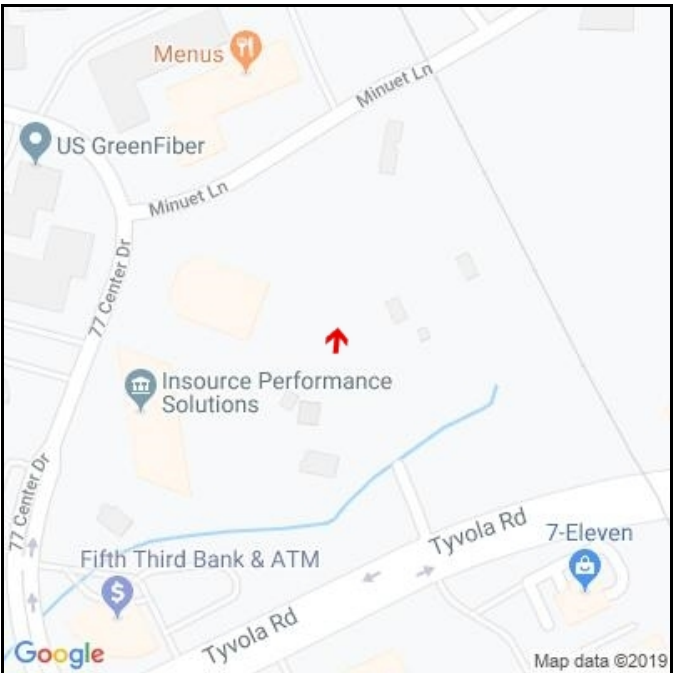
Attributes	
Description	Truck fuel stand. Spill kits (red bucket, 1 of 2 shown) had cracked lids and were filled with rainwater. Suggested that spill kits be replaced.

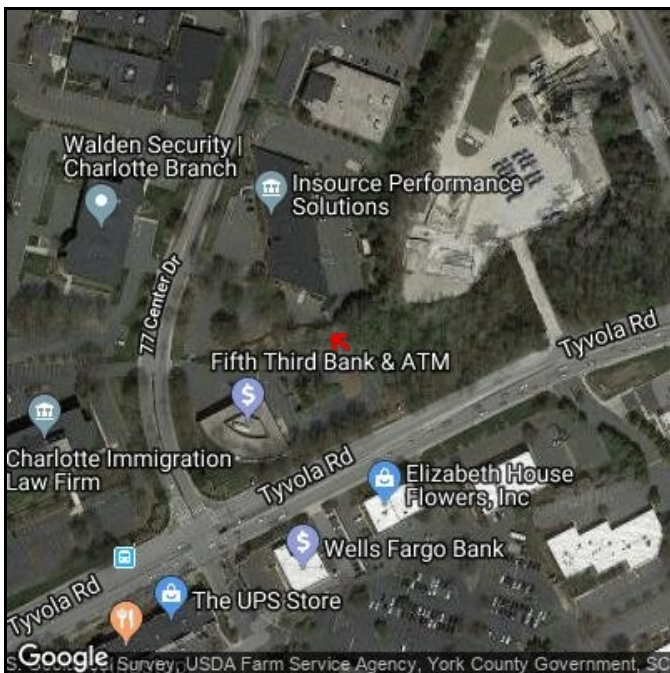
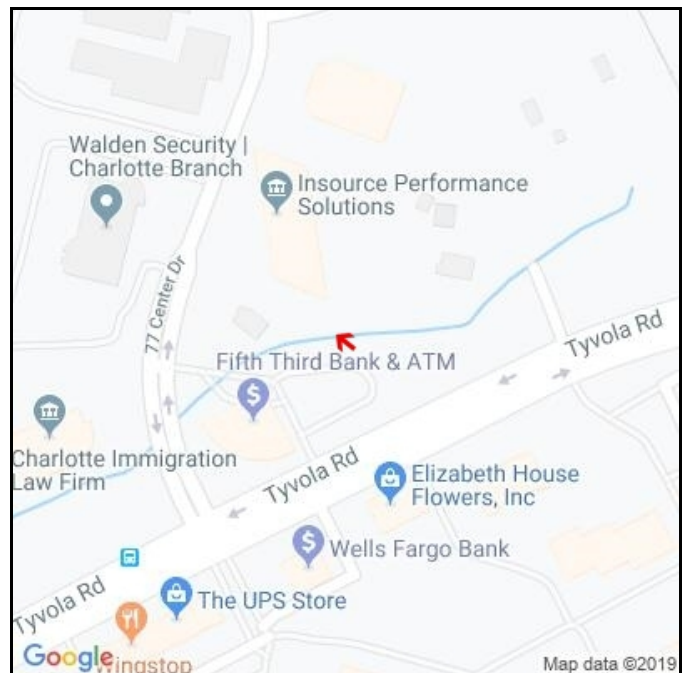
Description	After exiting the facility, inspectors looked at receiving water/ditch downstream of facility, where county had conducted sampling during the prior 12 months.
-------------	--
